Rapid Service Procedure

Rapid 25 (G.C. 47-291-08) Rapid 32 (G.C. 47-291-09)

Service variations (Rapid).

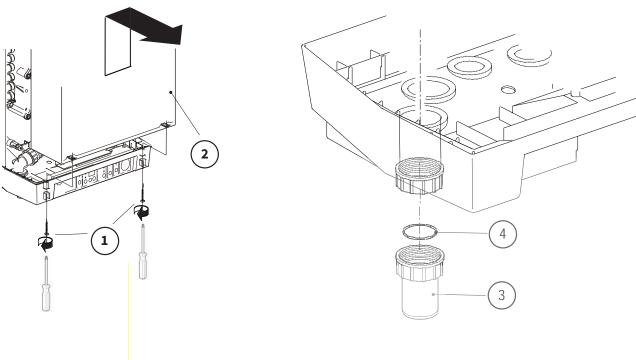
Syphon maintenance

- ► Detach the syphon cup (3) by rotating it to the left (anticlockwise) and then pulling it out downwards.
- ► Inspect and if damaged replaced the rubber seal (4)
- ► Empty the syphon cup (3).
- Clean the following components with water:
 - The inside of syphon
 - The syphon cup
 - The syphon seal
 - Flush the condense pipework
- ► Replace the syphon cup and ensure that is filled ¾ full of water.

- Always fill the condensate trap with water then attach it to the boiler before powering it up.
- ➤ To fill the condensate trap the hose between the trap and PRV should be removed (from the trap side). The hose must be re-attached after filling the trap!
- ► Not replacing or filling up the condensate trap can result in products of combustion entering the room leading to a potentially dangerous situation.

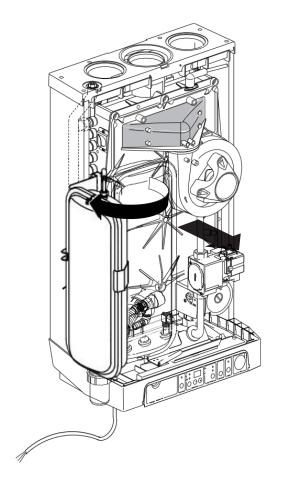
- Replace the front plate O-ring seal at least every 2 years or if damaged/ discoloured and /or if the front plate has been removed. Art.no: 086474 — Rapid 25 &32
- All red Silicon front plate seals must be replaced, regardless of age with the black Viton.
- Check or replace the seals and gaskets detailed in the following page at the requested intervals.
- ► The outer casing is a room sealed cover and therefore extremely important that it is fitted correctly, failure to do so could lead to products of combustion entering the room / environment where it is situated.
- ► Upon completion please fill out the relevant section of the Benchmark service record.
